JUSTIFICATION FOR AN OPERATING RESTRICTION IN SPAIN INCORPORATING ANCOLD GUIDELINES ON RISK ASSESSMENT

Manuel G. de Membrillera¹, Ignacio Escuder², David Bowles³, Eduardo Triana⁴, Luis Altarejos⁵

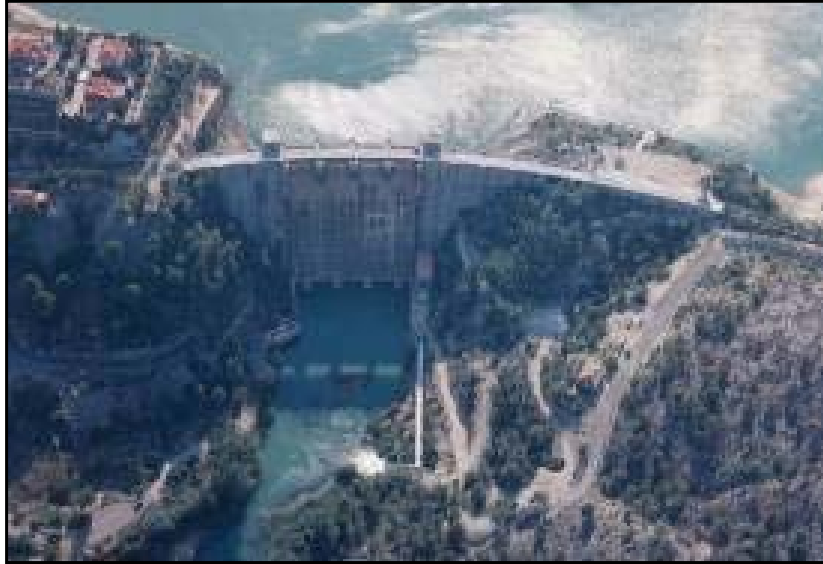
Figure 1. The study dam and reservoir.

The structure is a 57.5 m high concrete gravity multipurpose dam (irrigation, urban water supply and flood protection). The crest is 8 m wide and the length of the dam is 198 m. The four-span gated spillway is mechanically operated from the dam site. Figures 1 to 4 show the dam and reservoir, the main spillway, the limestone layers in the foundation, and the downstream face of the dam, respectively.

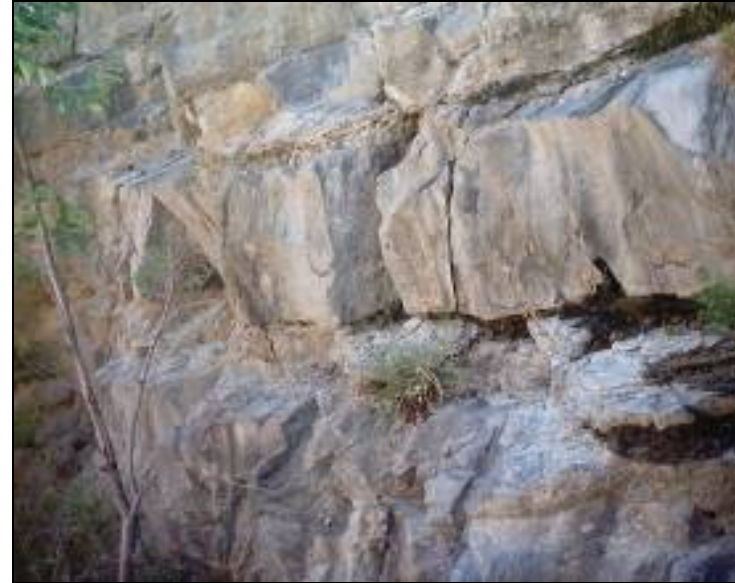
Figure 3. Close up of the limestone foundation with thin layers of clayey marl.

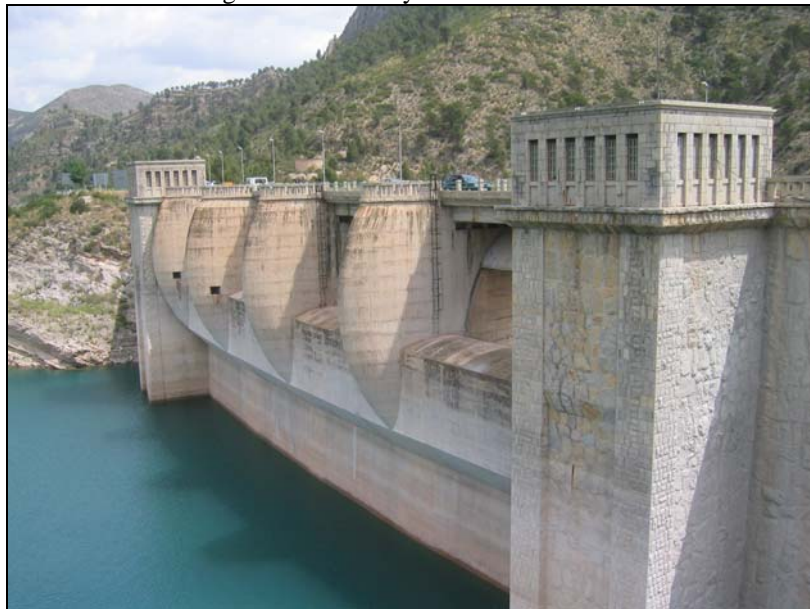
Figure 2. The main spillway from upstream.

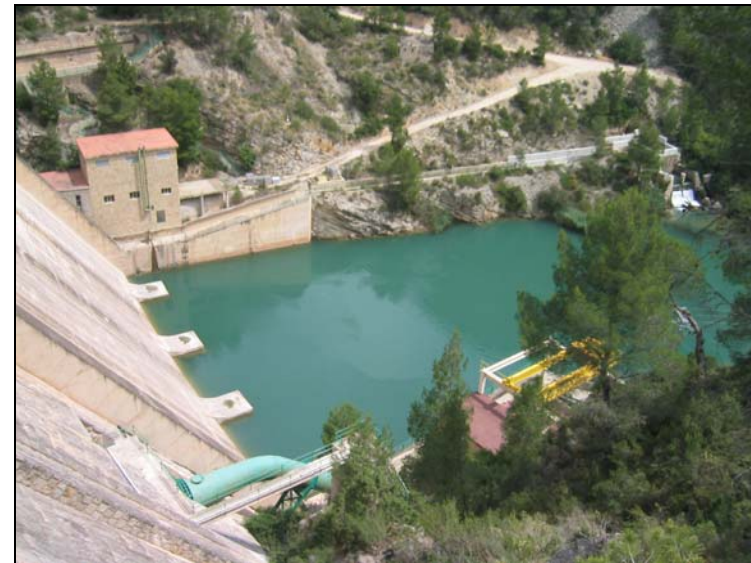
Figure 4. The downstream face of the dam from the right abutment.

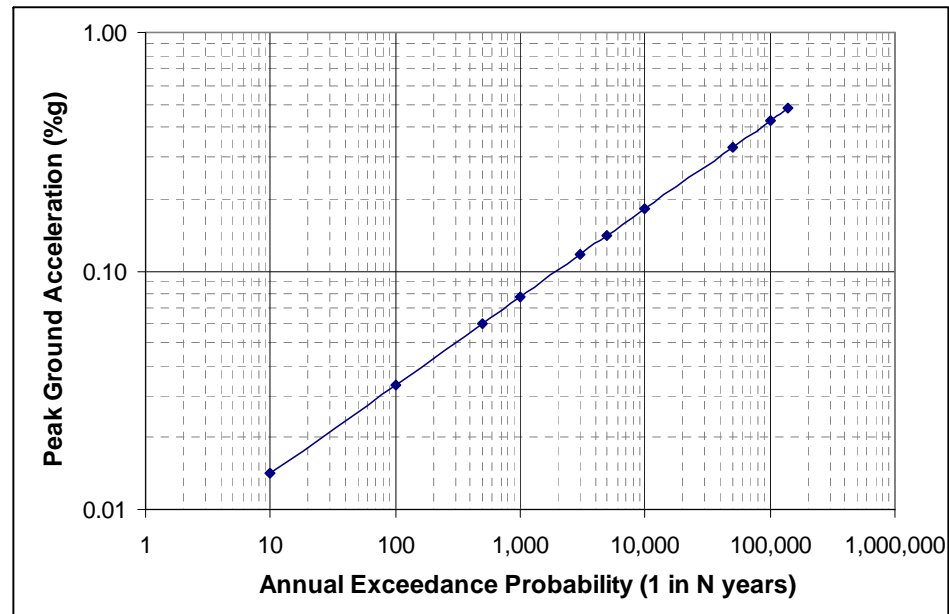
Figure 6. Earthquake loading (horizontal peak ground acceleration vs. AEP)

- The historic record of inflows and reservoir pool levels.
- Operating rules and existing demands.
- Seismic characterization according to the Spanish guidelines (Figure 6).
- Number and state of spillway gates.

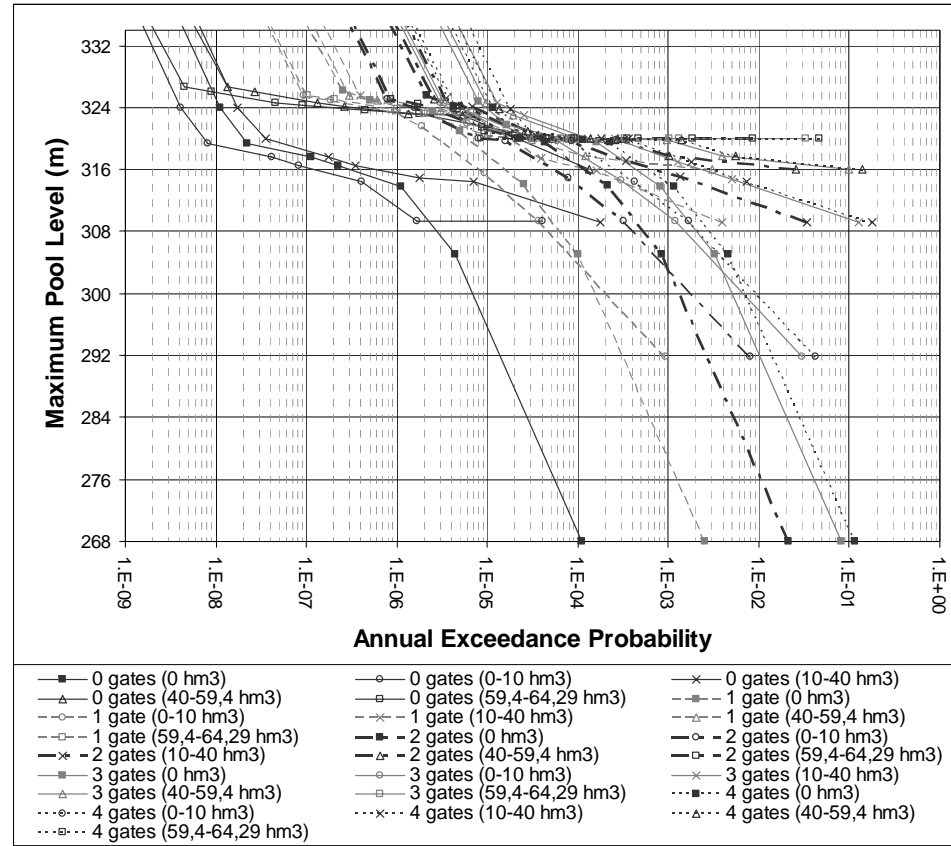
Figure 7. Flood and Flood Internal Loading (Peak Reservoir Stage – AEP) depending on spillway gate reliability and previous storage level.

For the flood and flood internal loading domain, separate reservoir level versus AEP relationships were developed for each gate operating reliability state (Figures 7 and 8).

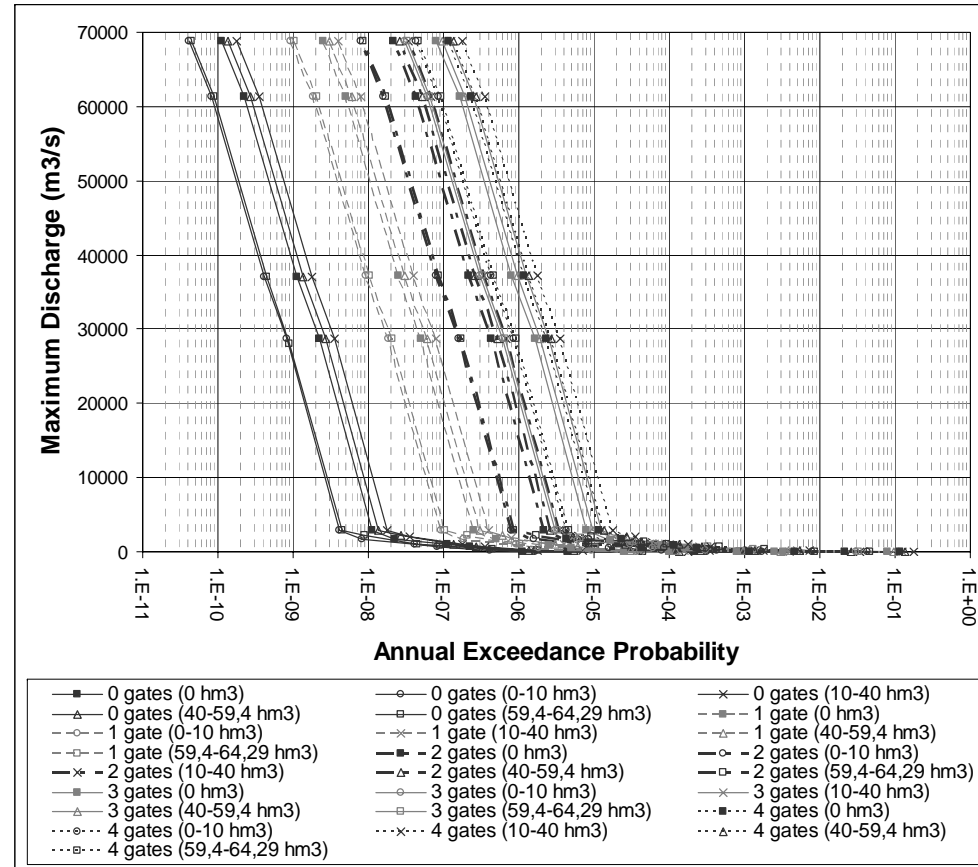
Figure 8. Flood and Flood Internal Loading (Peak Discharge – AEP) depending on spillway gate reliability and previous storage level.

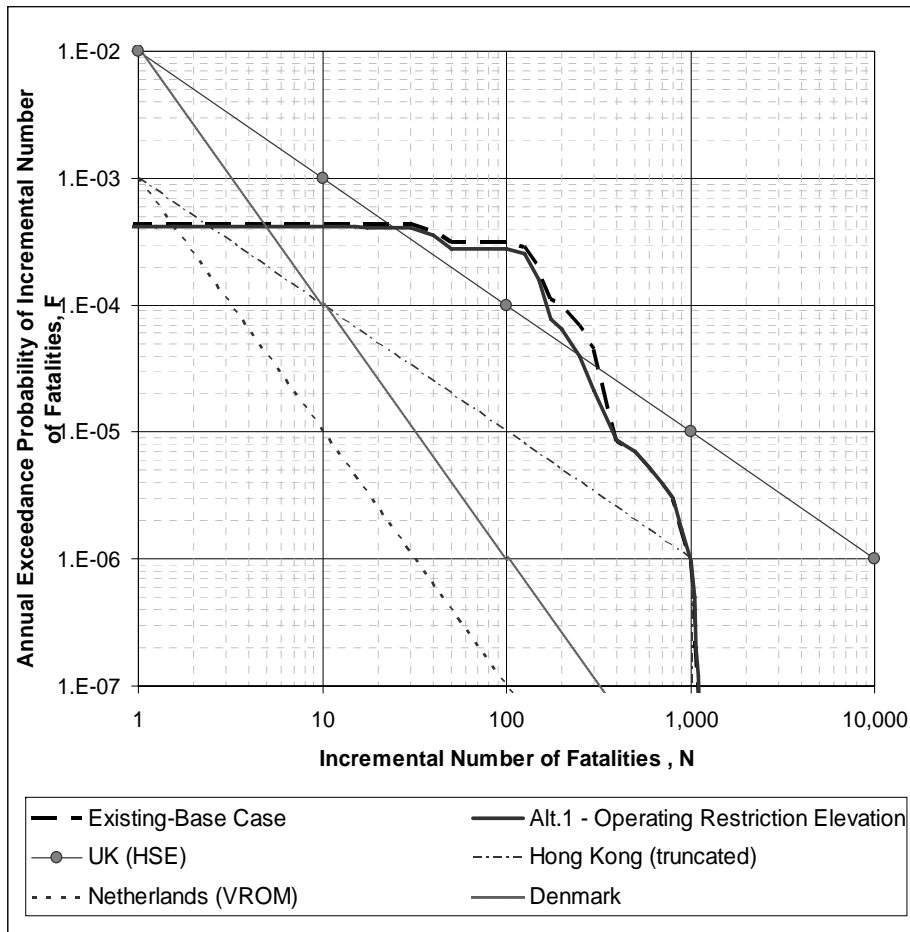
Figure 14. Risk tolerability criteria on Hazardous installations (Vrijling et al, 2004).

As can be drawn from Figures 12 to 16, none of the tolerable life safety risk guidelines were estimated to be met by the Base Case or the Operating Restriction. In both cases, the total Annual Probability of Failure is estimated to be very high. In addition, since floods that impose a clear threat to the dam are quite large, they would fill the reservoir rapidly such that the effect of the operating restriction is

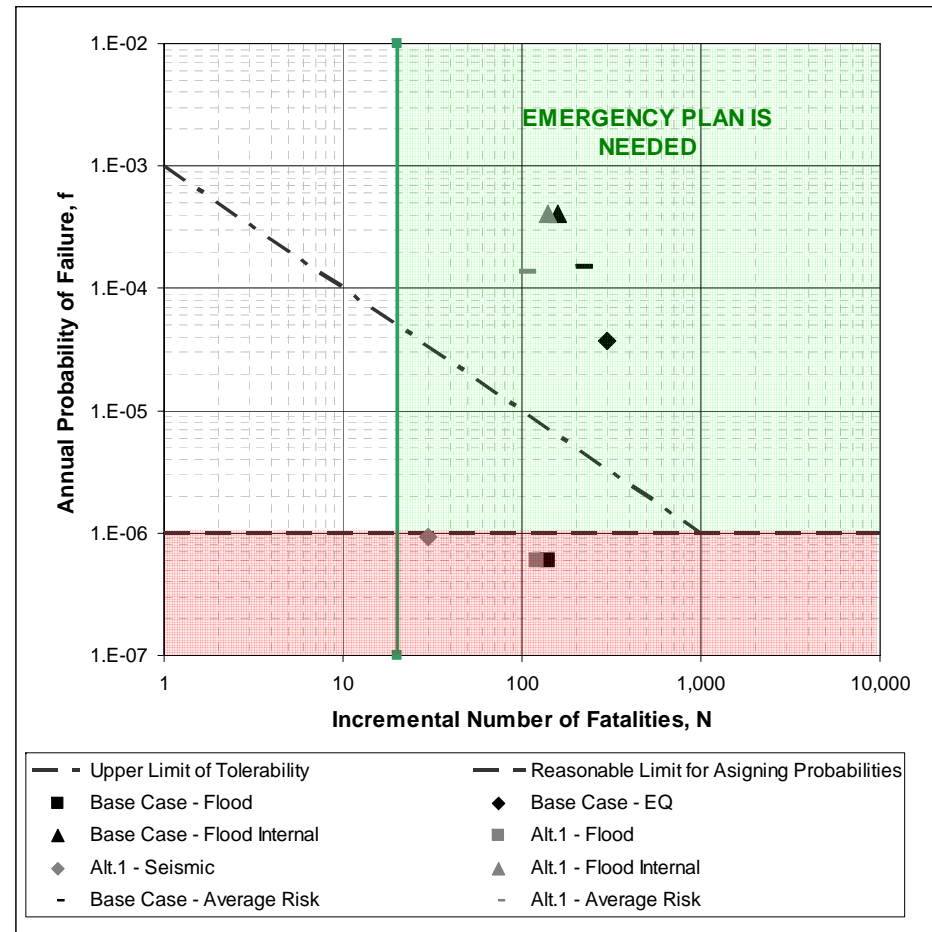
Figure 15. Criteria on Tolerable Societal Risk-Rettmeier et al 2001 (Germany).

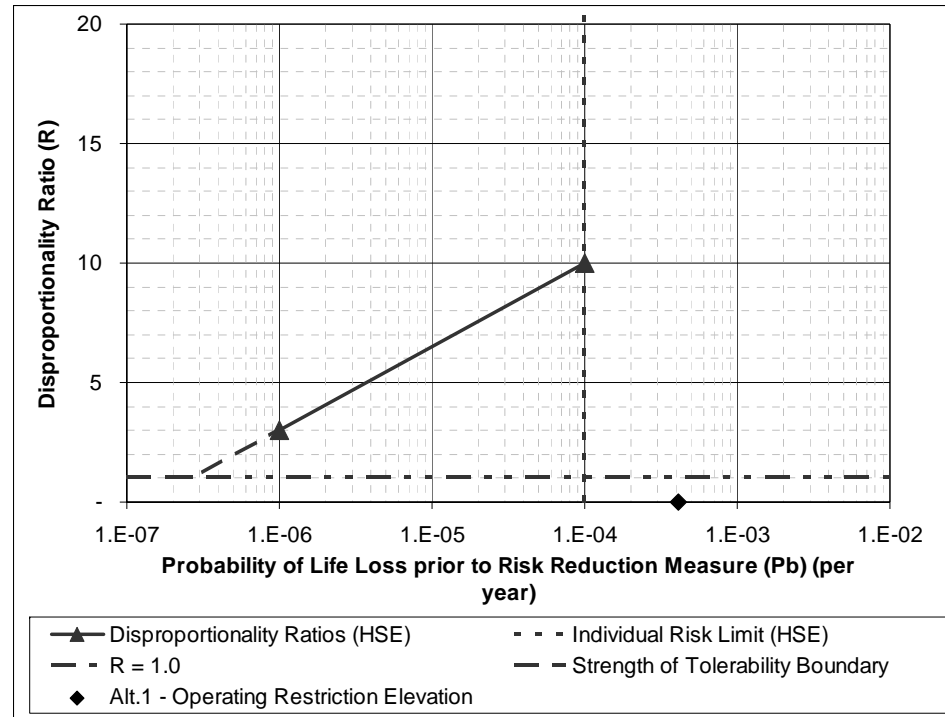
Figure 16. HSE Disproportionality ratios (Bowles 2003).

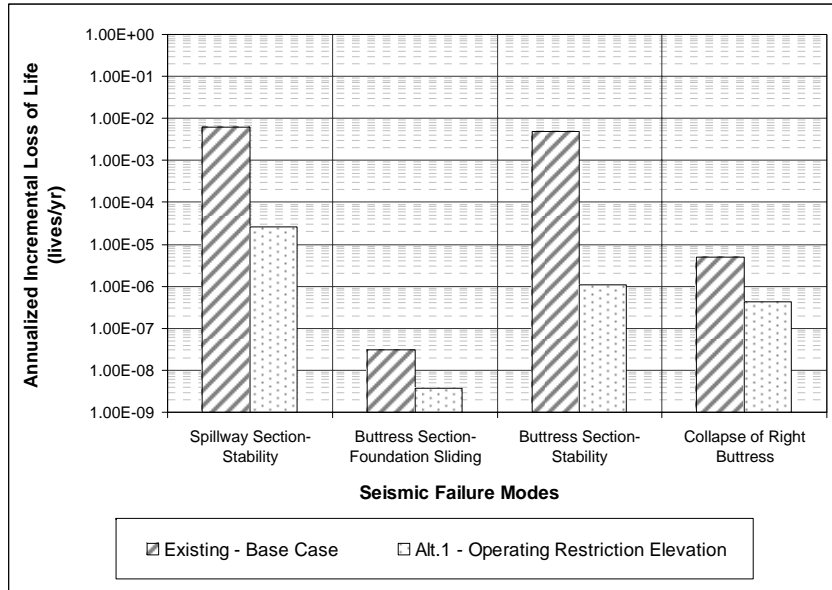
Figure 17. Annualized Incremental Loss of Life (lives/yr) - Seismic Event.

very small for floods and only noticeable in the earthquake event (Figures 17 to 19).

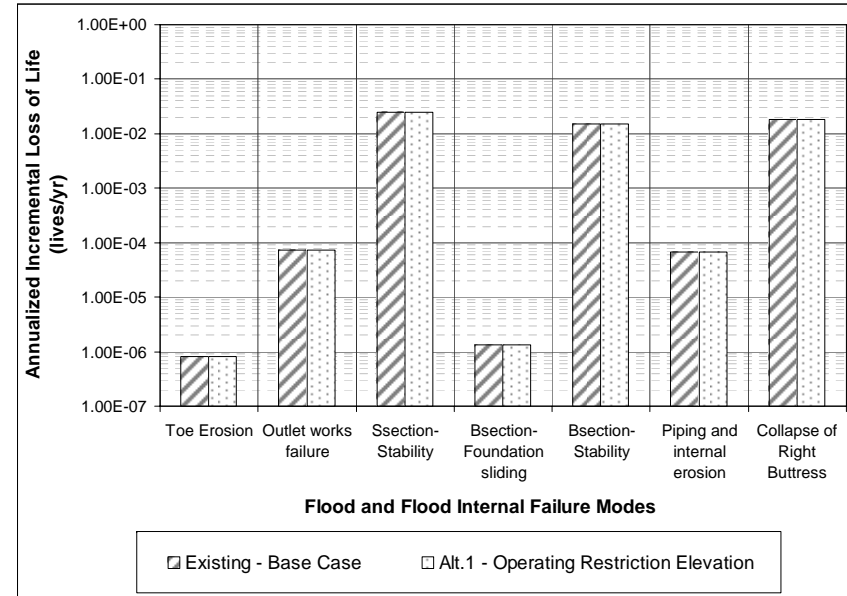
Figure 18. Annualized Incr. Loss of Life (lives/yr) – Flood and Flood Internal Events.

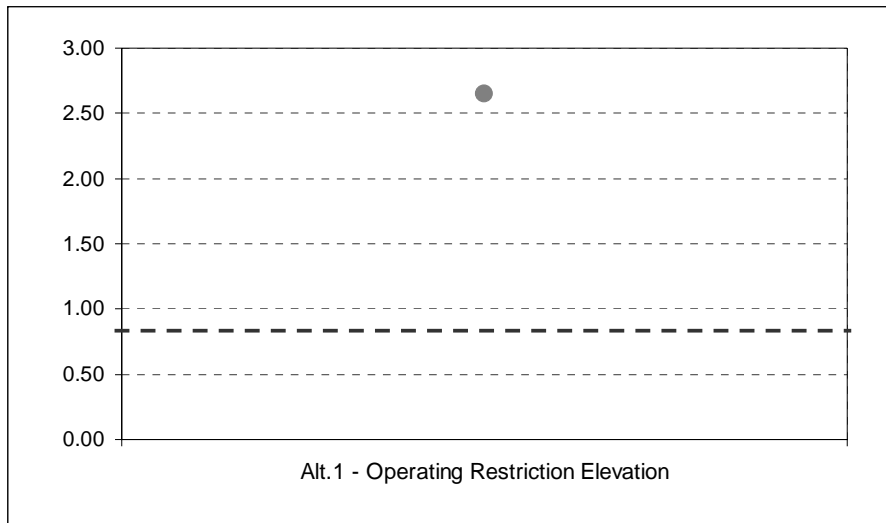
Figure 20. Benefit/Cost Ratio.

Still, the restriction can be justified in terms of economic efficiency as shown by the estimates of the benefit/cost ratio of more than 2.5, as shown in Figure 20, and the Adjusted Cost per Statistical Life Saved, which by convention is set to zero when the benefit/cost ratio is greater than 1.0. In addition, Figure 21 shows the reduction in Probability of Failure versus Annualized Risk Cost.

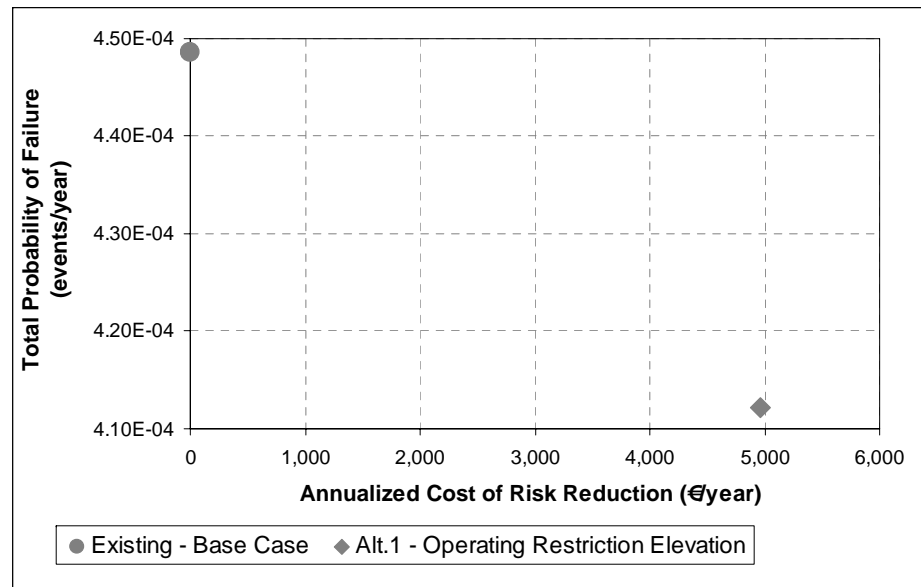
Figure 21. Reduction in Probability of Failure vs. Annualized Cost.
